# Manhole Inspection Summary

Manhole # S35AA1001MH

Insp Date: **3/26/07 10:40 AM**

**Location** Address: **110 34TH ST**

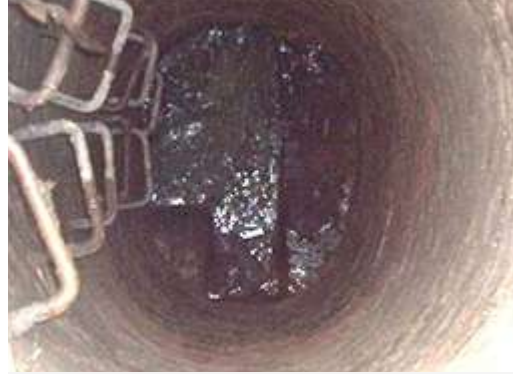
Top View

Corroded steps. Evidence of surcharge - Bench debris. Channel debris.

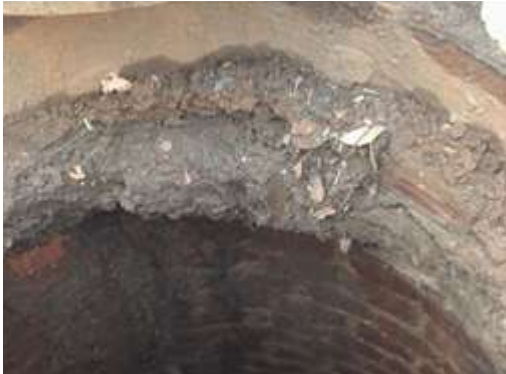
Defect

**Frame** Offset: **2** (in.) Condition: ☐ Sound ☐ Cracked ☒ **Leaks**

Frame leaks. Frame offset. Adjustment deterioration and infiltration.

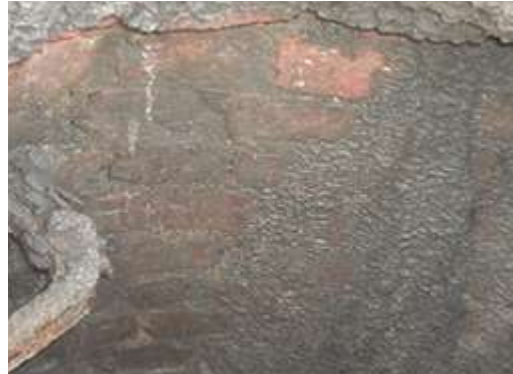
Defect

**Chimney / Frame Adjustment** ☒ Exists Material: **Brick** ☐ Parged Height: **3** (in.)  
Condition: ☐ Sound ☐ Cracked ☐ Root Intrusion ☐ Loose Brick ☒ **Deteriorated**  
Infiltration: ☐ None ☒ **Joint** ☐ Cracks ☐ Mortar ☐ Roots ☒ **Wall**

Adjustment deterioration and infiltration.

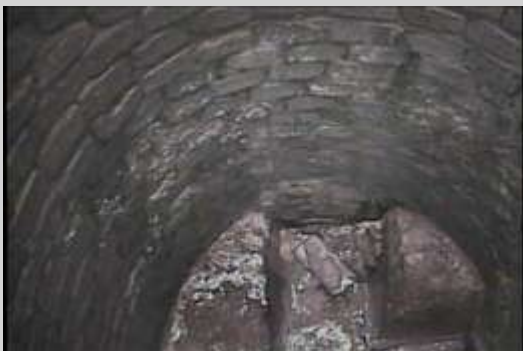
### Pipe In @ 6 O'Clock

**Barrel** Material: **Brick** ☐ Parged  
Shape: **Circular** Diameter: **46** (in.) Length: (in.)  
Condition: ☐ Sound ☐ Cracked ☐ Root Intrusion ☐ Loose Brick ☒ **Deteriorated**  
Infiltration: ☐ None ☐ Joint ☐ Cracks ☒ **Mortar** ☐ Roots ☒ **Wall**

Barrel deterioration and infiltration.

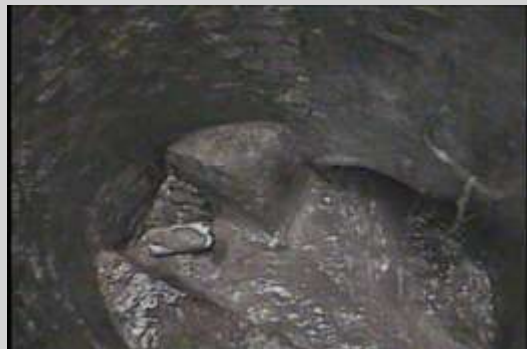
Pipe In @ 9 O'Clock

**Surcharge** ☒ **Evidence Of Surcharge** Depth: **1.5** (ft.) ☐ Active Surcharge Present

Evidence of surcharge.
